Failure Analysis of an AH-64 Main Rotor Damper Blade Rod End, P/N 7-211411186-5

ARL-TR-3100

December 2003

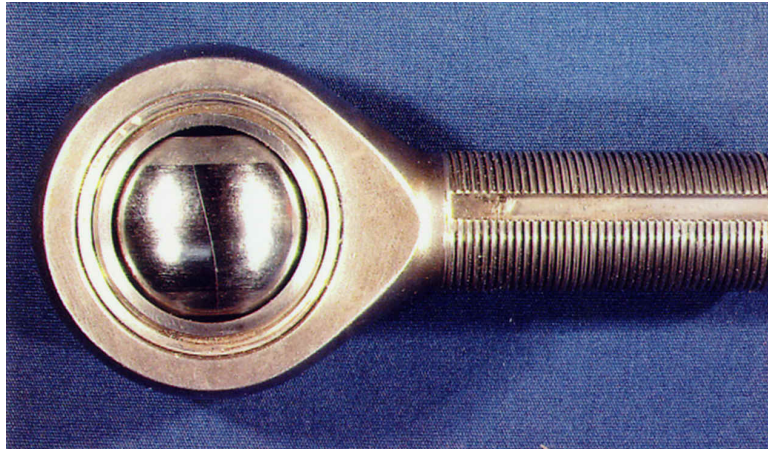
The failed part is shown in figure 2 in the as-received condition (approximately 1x magnification). The ball component of the assembly contained a “through” (i.e., complete) crack that was observed along the exterior as well as the interior (see figure 3). The body and the outer ring were sectioned by ARL in order to extract the cracked ball. Special care was taken not to damage the crack. Figures 4 and 5 show both halves of the cracked ball. One half of the ball, subsequently labeled “A” (see figure 4), was cleaned in an Alconox solution to remove the

Figure 2. Failed component in the as-received condition (mag ~1x).

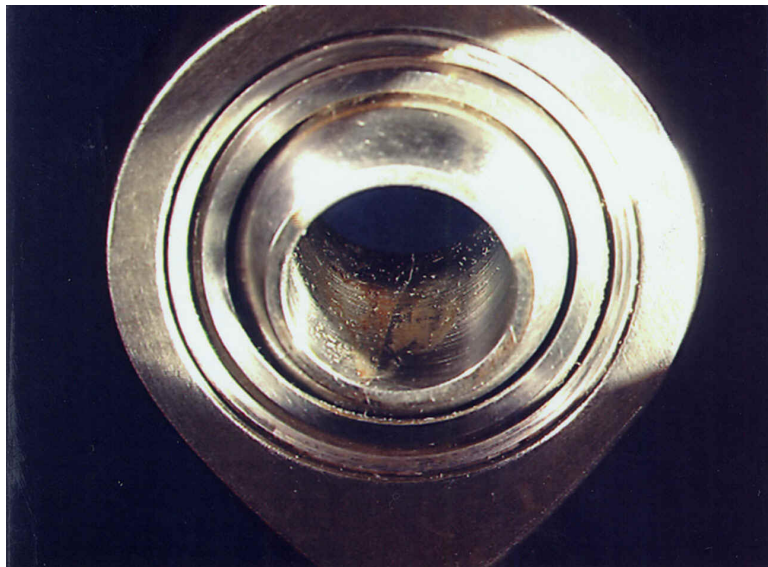
Figure 3. Through crack visible along the interior bore (mag ~2x).

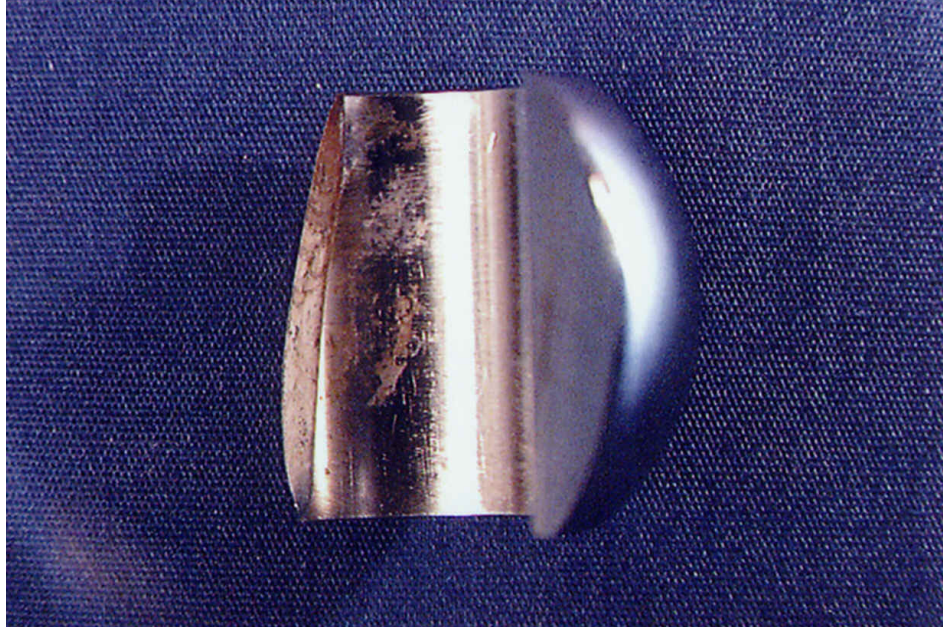
Off-axis views of the ball halves are presented in figures 6 and 7 to detail the corrosion observed along the internal bore of the ball near the through crack. This corrosion may have formed after the crack propagated entirely through the ball.

Figure 6. Fracture half “A” showing corrosion along the inside bore (mag ~2x).

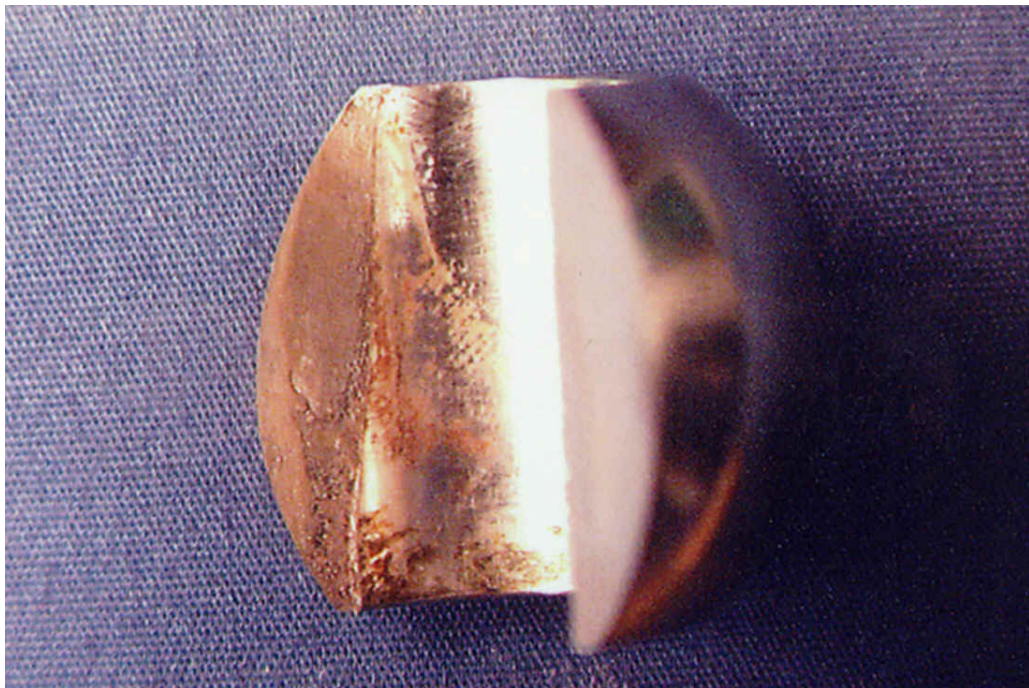
Figure 7. Fracture half “B” depicting corrosion along the inside bore (mag ~2x).

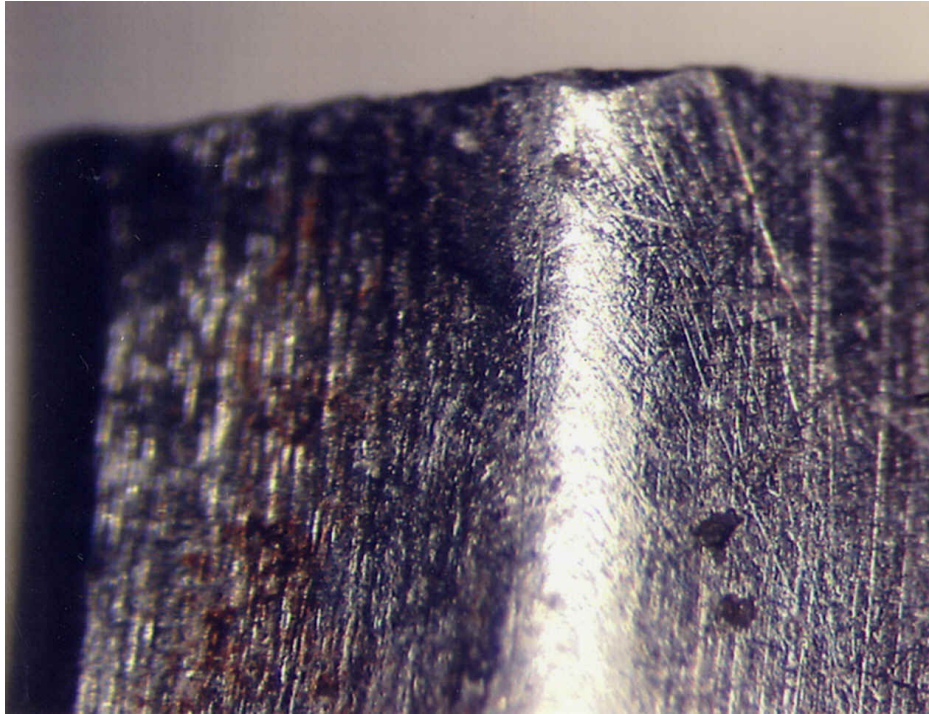
Further examination of fracture half “A” revealed numerous corroded areas, as shown in figures 9 through 11. The areas of attack were approximately 0.19, 0.04, and 0.01 inch from the origin. Figure 12 depicts the sites in figure 11 at higher magnification to show detail more clearly.

Figure 10. Attacked areas near origin of fracture (mag ~50x).

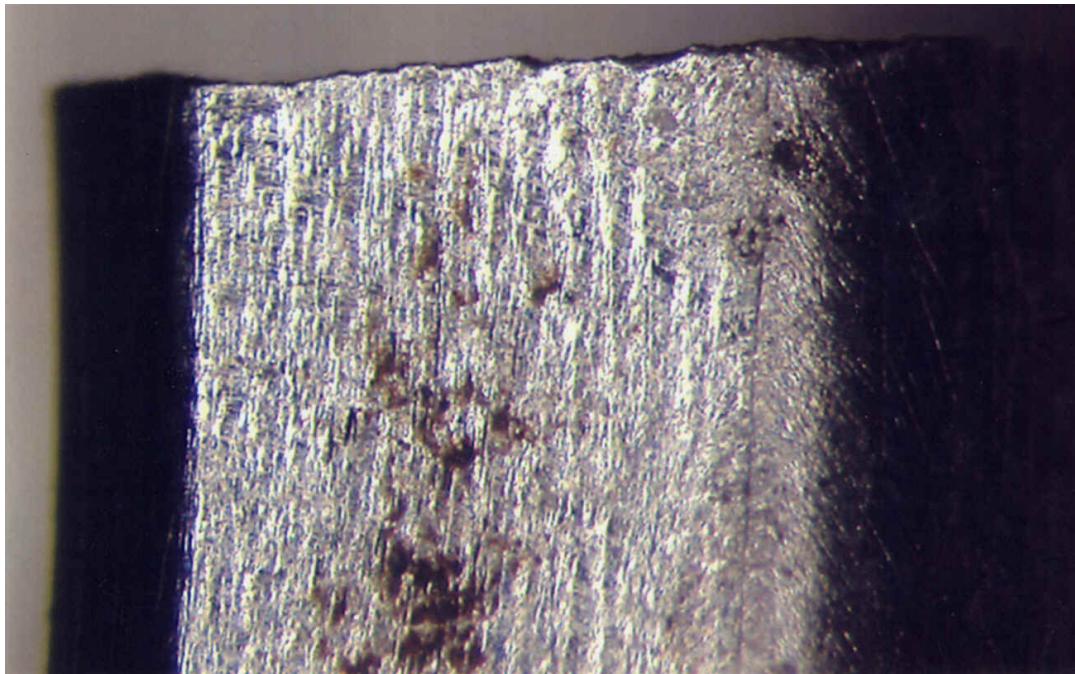
Figure 11. Corrosion on chamfered edge adjacent to fracture plane (mag ~40x).

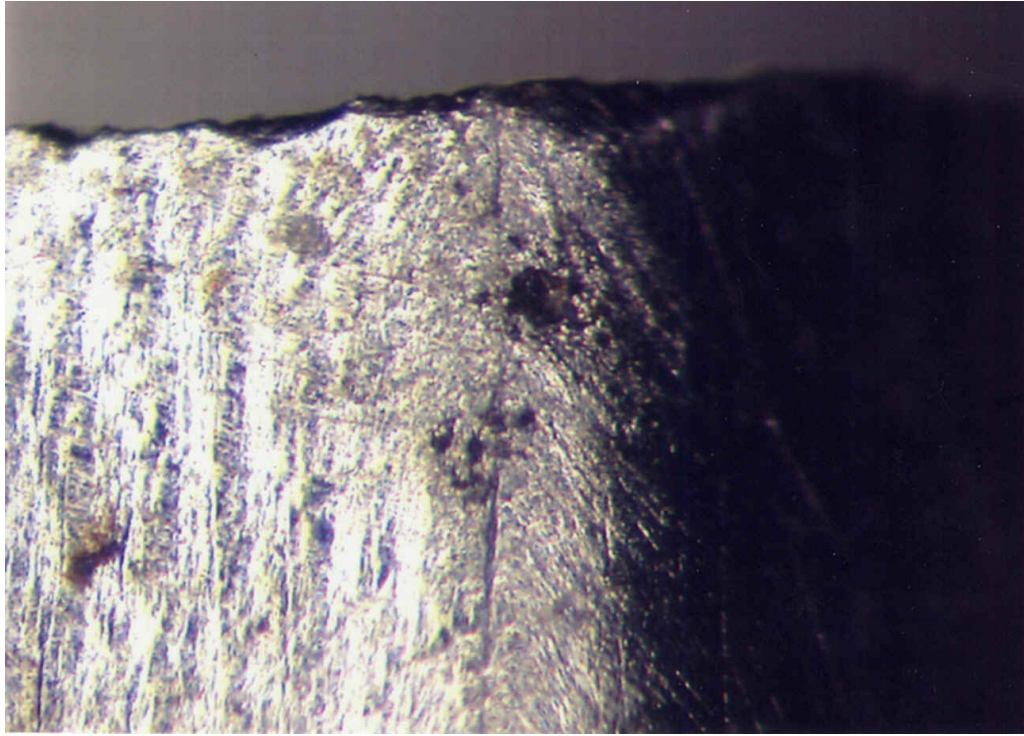
Figure 12. Detail of Figure 11 showing localized corrosion near origin (mag ~100x).

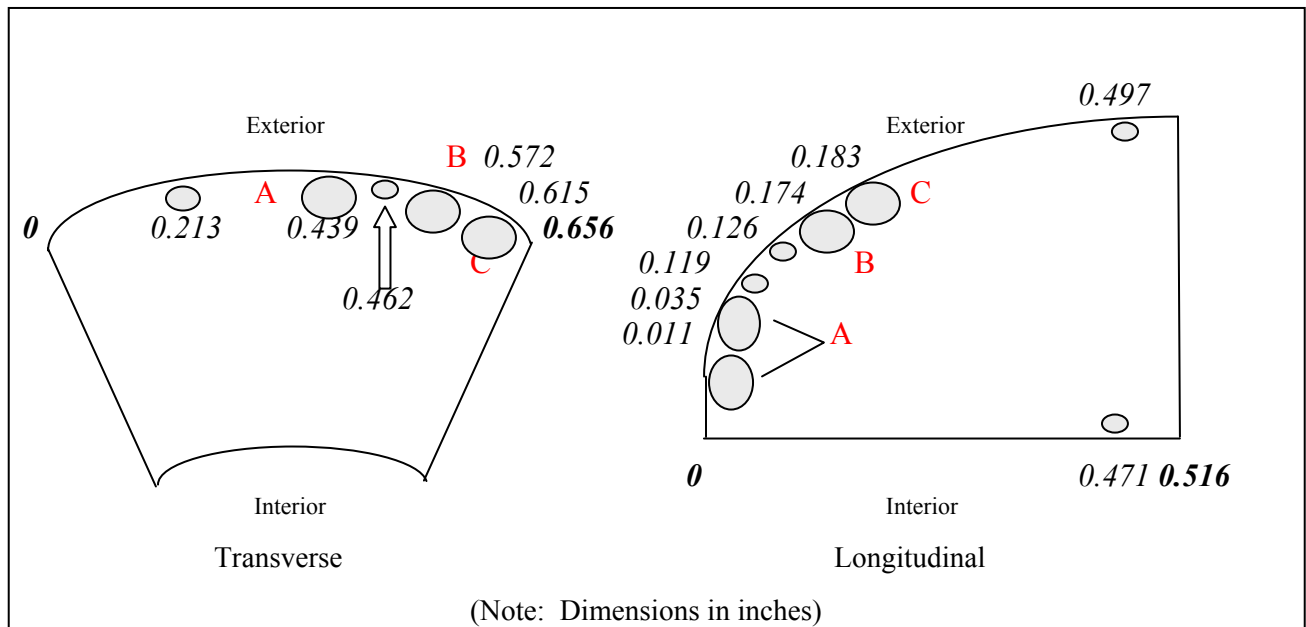
The specimens were examined in the as-polished condition. Localized regions of surface inter-granular attack were noted in the areas shown in figure 16. The corresponding measurements were approximated with simple geometry. Except for one very small region on the interior of the longitudinal sample (see figure 16), each region of attack was noted on the exterior surface of the part. It was interesting to note that the bulk of the inter-granular regions observed on the longitudinal sample corresponded to the general location of the fracture origin.

Figure 16. Schematic of localized inter-granular attacked locations.

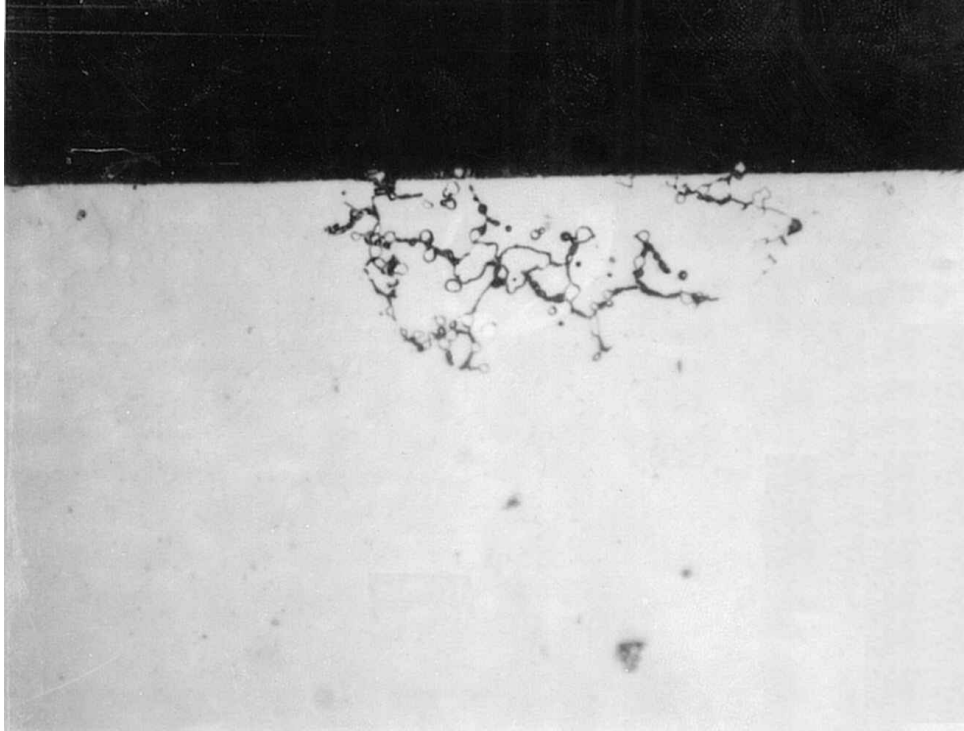
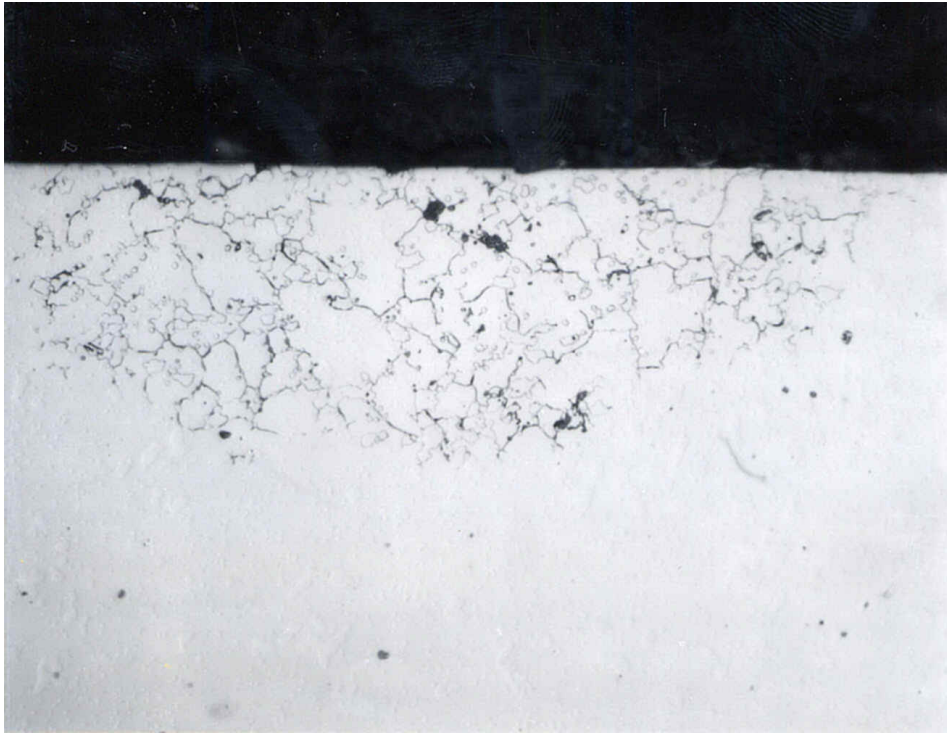
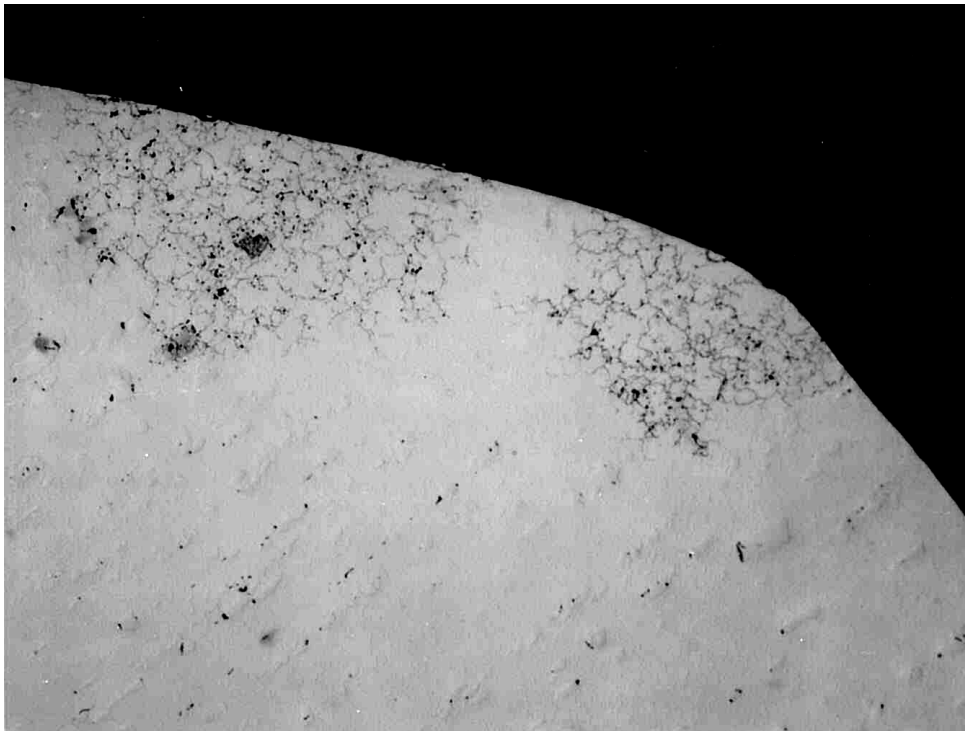
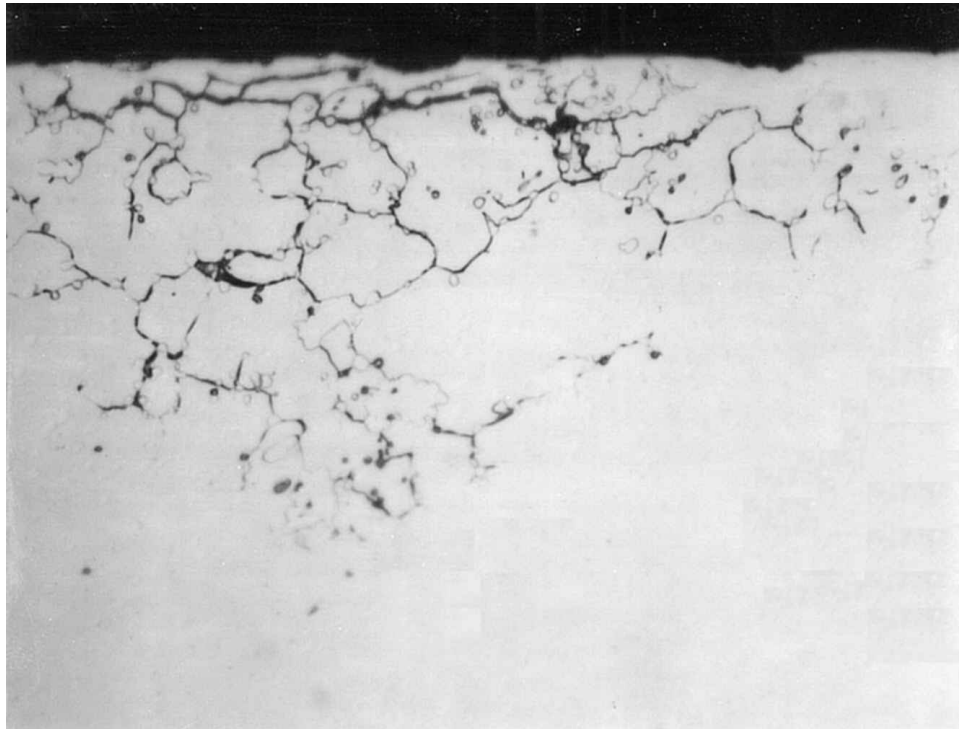
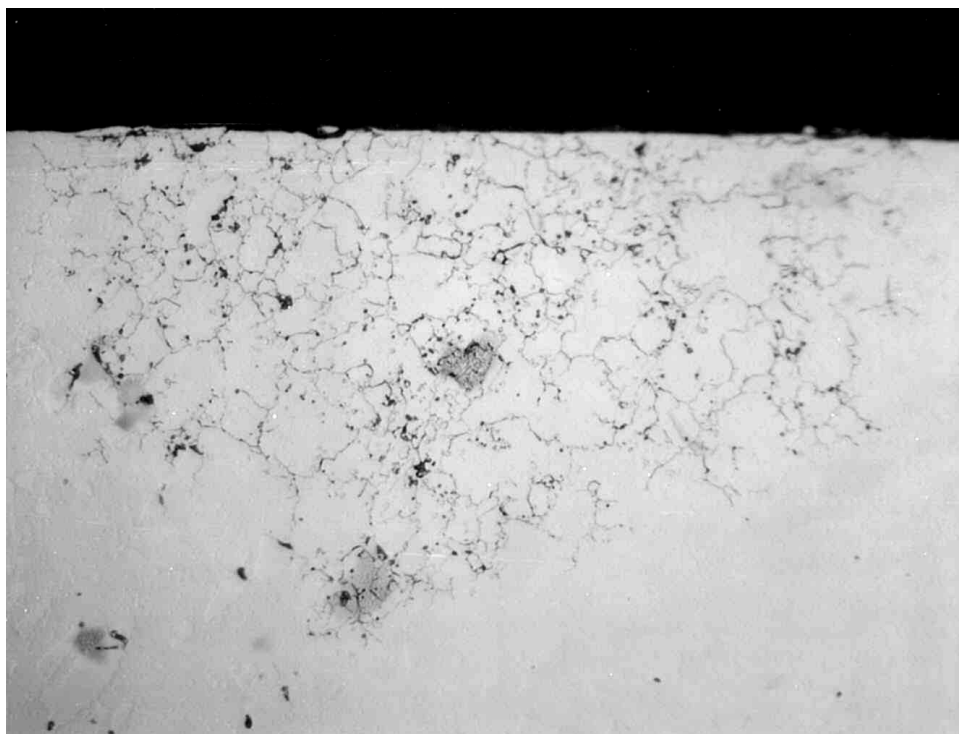
The regions of attack labeled “A,” “B,” and “C” in figure 16 are shown in figures 17, 18, and 19 for the transverse section and in figures 20, 21, and 22 for the longitudinal section, respectively. In these photomicrographs, it is apparent that inter-granular cracks progressed to and around the precipitates (figures 17 and 21, especially). This fact is intuitive when it is realized that the matrix is inherently depleted of chromium in these areas. Figure 18 shows that individual grains of metal have actually been dislodged from the network of inter-granular attack, forming a cavity or pit at the surface of the part.

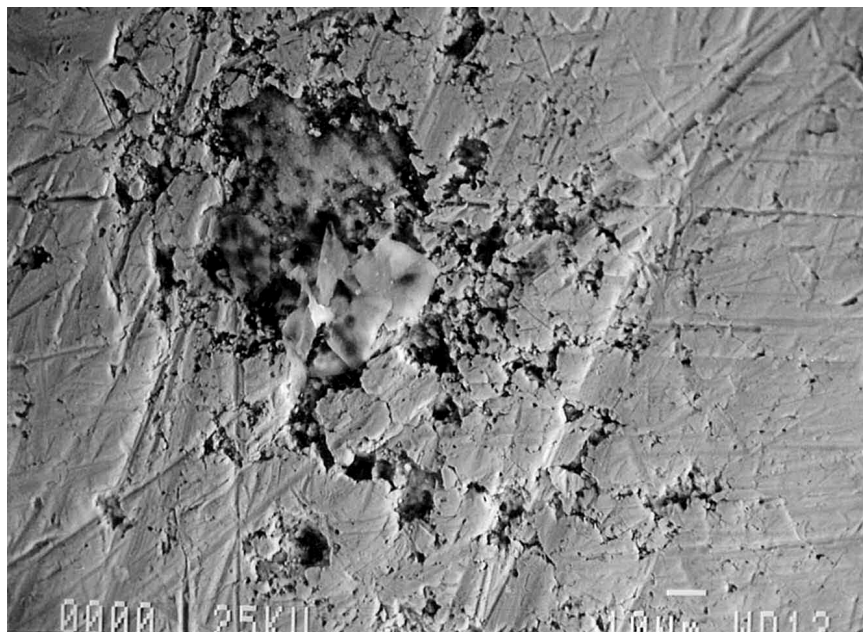
Closer inspection revealed inter-granular attack within and near the origin. Figure 35 depicts the likely fracture origin and the surrounding area at higher magnification at a 45-degree tilt angle with respect to the fracture surface. The large area of attack near the origin in figure 35 can be observed in figure 36.

Figure 36. Area of inter-granular attack near the origin (mag. 500x).

The attacked area was filled with corrosion product. This product was analyzed with EDS. The EDS spectrum produced from this product can be observed in figure 37. It was similar in chemistry and composition to the other attacked areas on the ball. However, it was slightly different from the corrosion product on the fracture surface that is presented later.

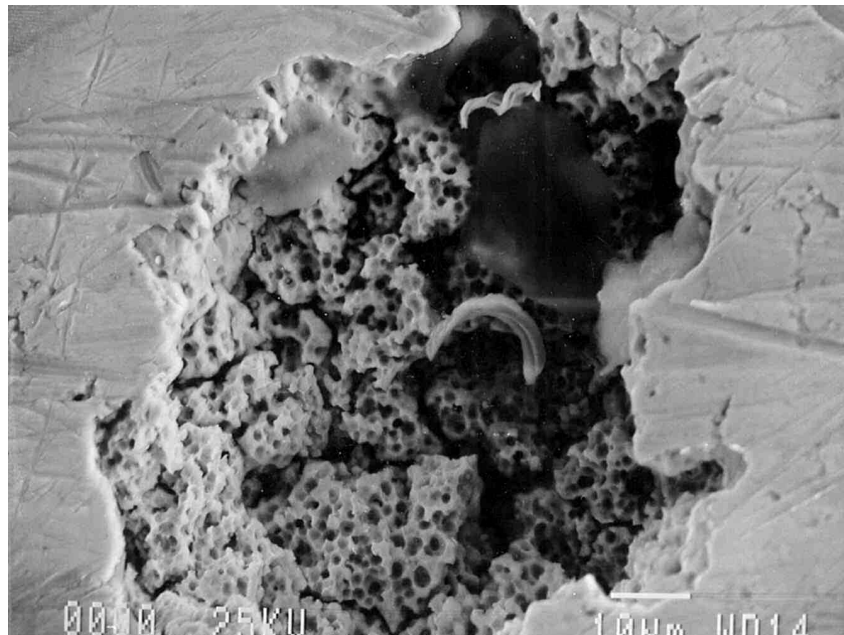
attacked. Conversely, they are dislodged by the attack. Figure 40 depicts this region. The depletion of chromium in the regions surrounding the precipitates makes this occurrence intuitive. The white arrows indicate the precipitates in advancing stages of dislodgment. Figure 41 presents the precipitates shown in figure 40 at higher magnification. Other inter-granular attacked areas demonstrated evidence leading to this conclusion.

Figure 40. Inter-granular attack site with dislodged precipitate (mag. 1kx).

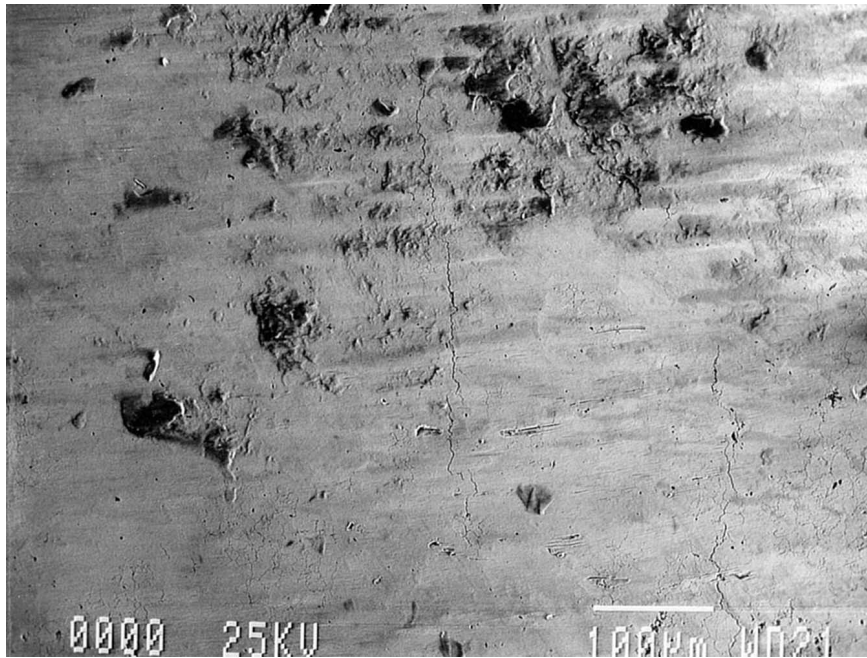
Secondary inter-granular cracks that propagated parallel to the fracture plane were observed within 2 mm of the fracture. These cracks were observed along the flat surface adjacent to the bored hole. Figure 46 depicts the multitude of these cracks highlighted with arrows. At higher magnification (see figure 47), an excellent example of inter-granular cracking preferentially around surface precipitates was observed.

Figure 46. Secondary cracks near and parallel to the fracture surface (mag. 150x).

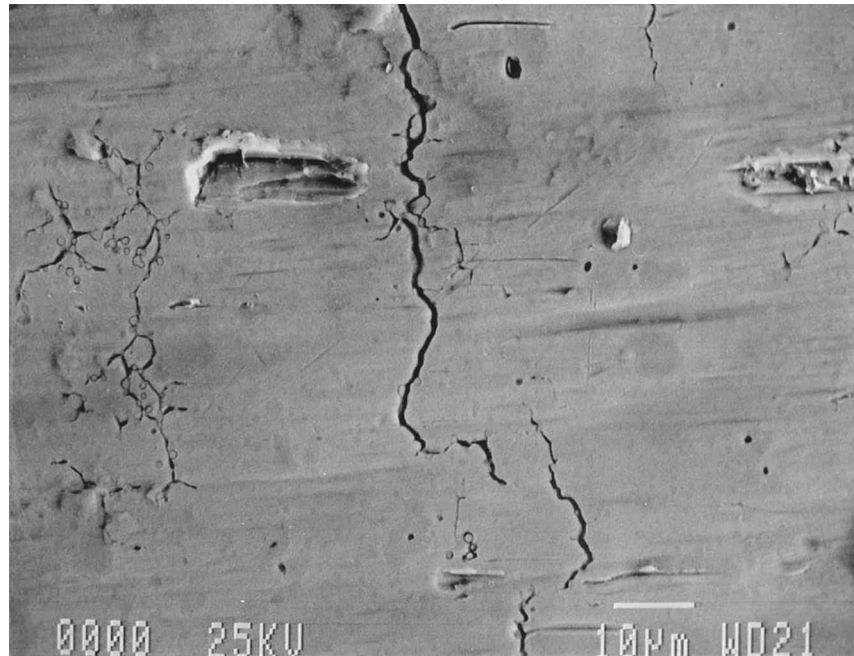
Figure 47. Preferential inter-granular cracking around precipitates (mag. 1kx).
